# MiTo Tailgate Release Guide

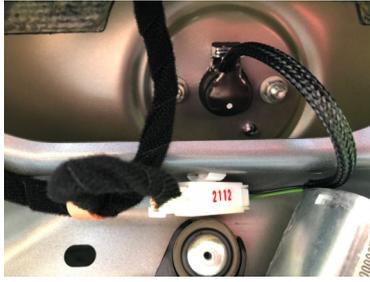
With the trim removed, you can see the back of the boot release.

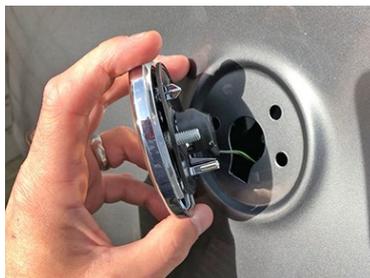
With the nuts removed, the mechanism simple comes away from the tailgate. Before replacing it, be sure to clean and polish your boot as you will be surprised at the amount of dirt that collects under the badge.

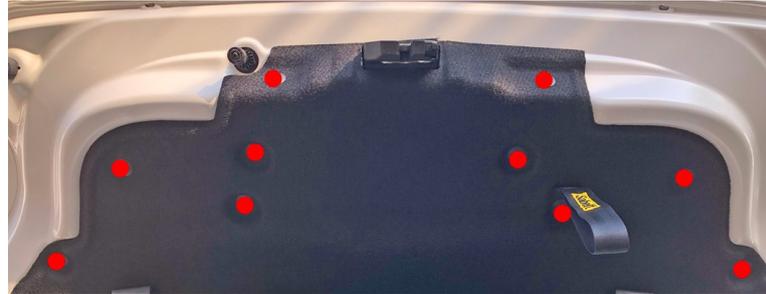
Step 1: Remove tailgate trim by gently easing off the ten clips

The tailgate trim is held on with ten plastic clips highlighted in red. Gently pull each clip off with either a trim removal tool or a flat knife. Once all the clips are removed, the trim has to be lifted UP the tailgate window as there are two clips which slide down onto the metal of the tailgate. This is important to remember when you re-fit the tailgate trim later.

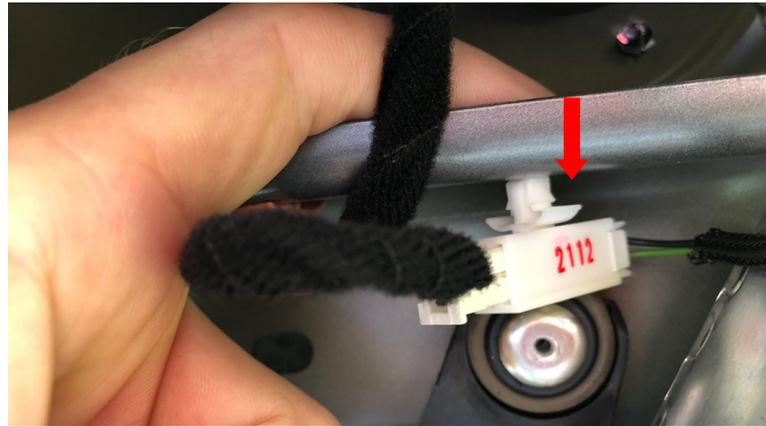
Step 2: Pop-out the wiring connector with your finger

If you have the older (type 1) mechanism with wiring attached, use your finger to pop out the wiring connect from the metal-work (see image, right).

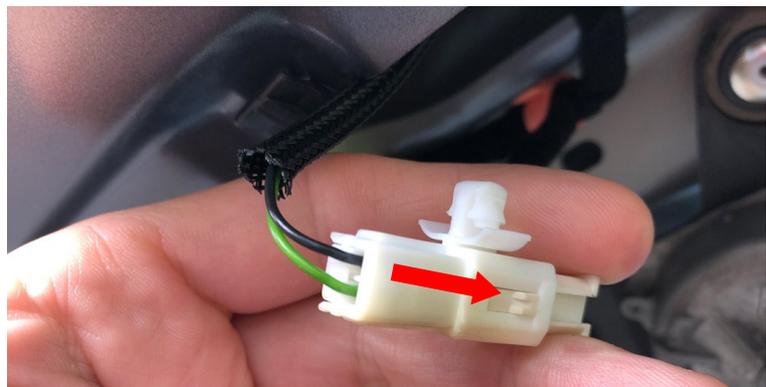
Step 3: Disconnect wiring connection by pushing as indicated

The MiTo wire to the boot release mechanism is the same whichever type your car has; it either slips into the wire from the mechanism (type 1) or directly into the back of the mechanism (types 2 and 3). Just push the small plastic clip (indicated in the picture below right) on the side of the connector to release the coupling.

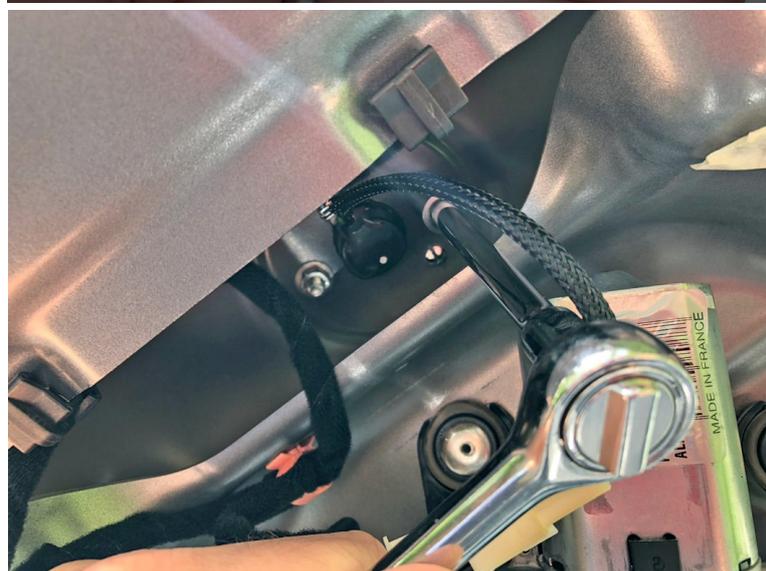
Step 4: Remove both 10mm nuts to release the mechanism

With a 10mm socket extension, remove both the nuts holding the boot release mechanism to the tailgate. Take care not to drop or lose them!
