MiTo Heater Resistor

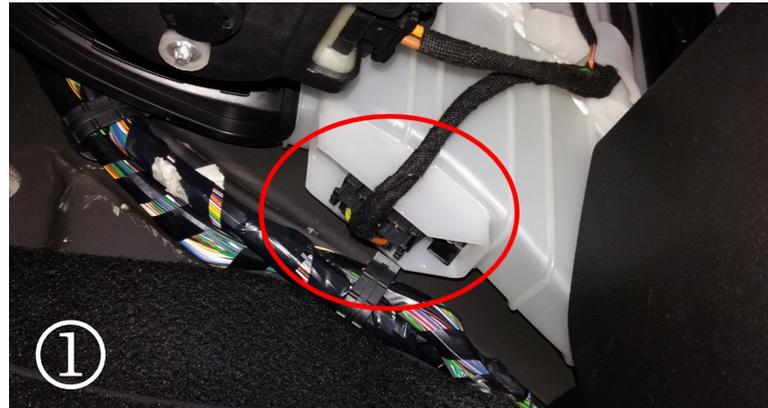
The resistor itself is not visible, but the wiring loom attachment to the connector is, as you can see in the first picture.

Under the glovebox you will find the wiring loom attaching to the connector (pic. 1).

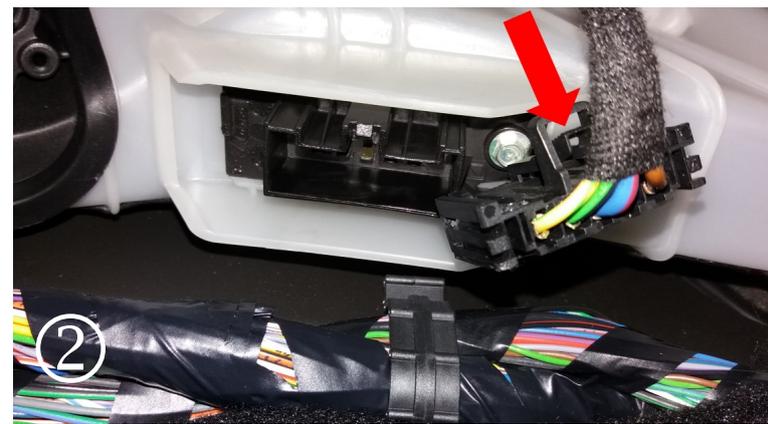
Firstly (having disconnected the battery), remove connector by pushing down the clip arrowed in pic. 2. This allows you to pull the connector off.

You will see to the right of the plug is a 5.5mm bolt – it's an odd size, so if you have a 5.5mm socket you'll be fine,

otherwise use small mole grips or maybe even pliers. It didn't seem terrifically tight on my MiTo.

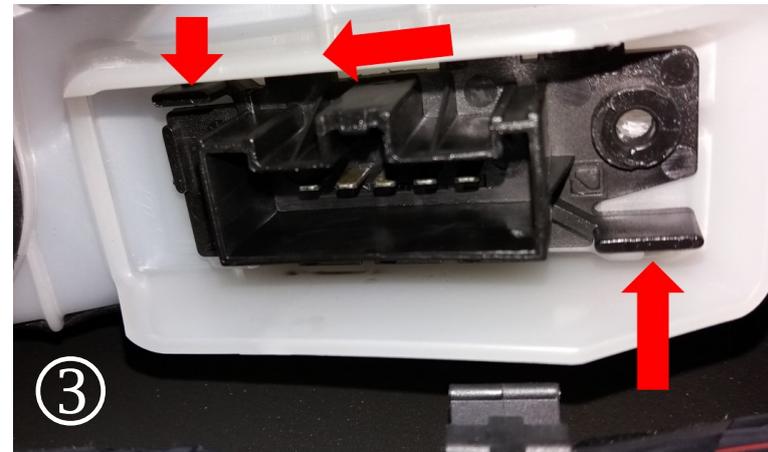
Once the bolt is removed, there is a fiddly way of removing the actual resistor (pic. 3). There are two clips (one at each end) which need to be pushed (the left one down, the right one up) whilst simultaneously moving the whole unit to the left to release. It may take a little time but it does come out eventually.

Gently remove the resistor and compare it to your replacement. They should be identical. Fitting is the reverse of removal (slide in the new resistor pushing it to the right, screw the 5.5mm bolt in (do not over-tighten for next time!), then re-connect the wiring loom to the resistor and re-connect the battery).
